**Capital Region Transportation Council  
Technical Assistance Program**

**TECHNICAL MEMORANDUM**

**Town of Ballston Intersection Traffic and Safety Assessment 5-2-2025**

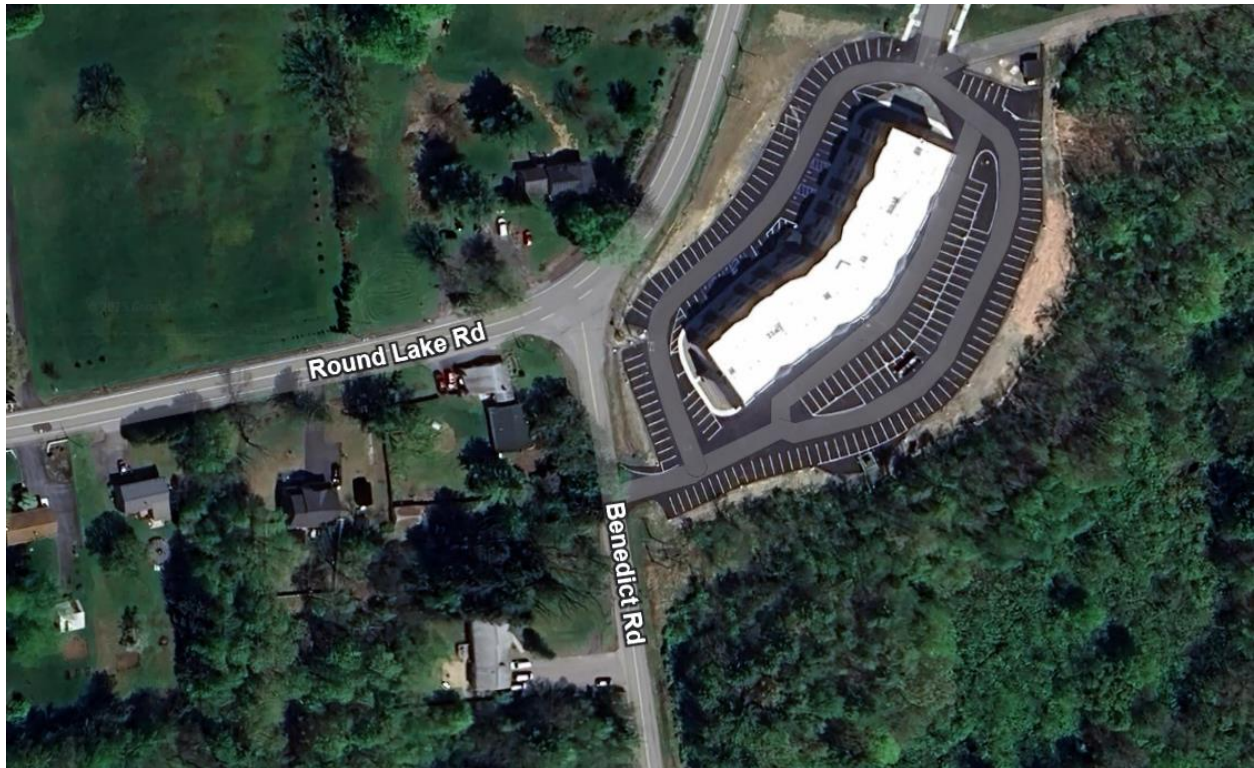
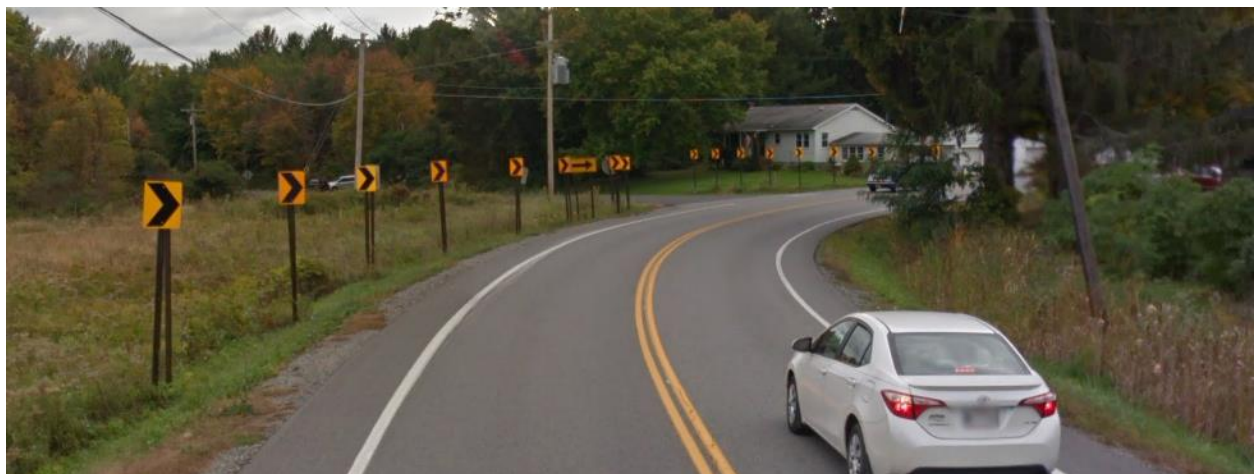
### Round Lake Round and Benedict Road:

- Three-legged intersection within a horizontal curve. The curve advisory speed is 20 mph, with 45 mph speed limit on the Round Lake approaches. Tight curve with approximately 300 foot radius. There is also a gradient sloping down to the south.

- Roadside hazards are present, including speed embankment on the southeast corner, utility poles, and a home on the southwest corner that has been struck multiple times.

- No lighting at intersection.
- Limited sight distance on certain movements due to horizontal curve.
- Saratoga County stakeholders report that improper speed, driver impairment, and sign blindness may contribute to crashes at this location.

Recommendations at this location relate to moderating vehicle speed on the approach to the horizontal curve, improving visibility and awareness of the curve, and improving pavement friction. These recommendations are consistent with MUTCD and NYSDOT Roadway Departure Safety Action Plan guidance. Many of the recommendations made here may also be applicable to other curves on Round Lake Road. Round Lake is a County road, so coordination with Saratoga County on advancing these recommendations is required.

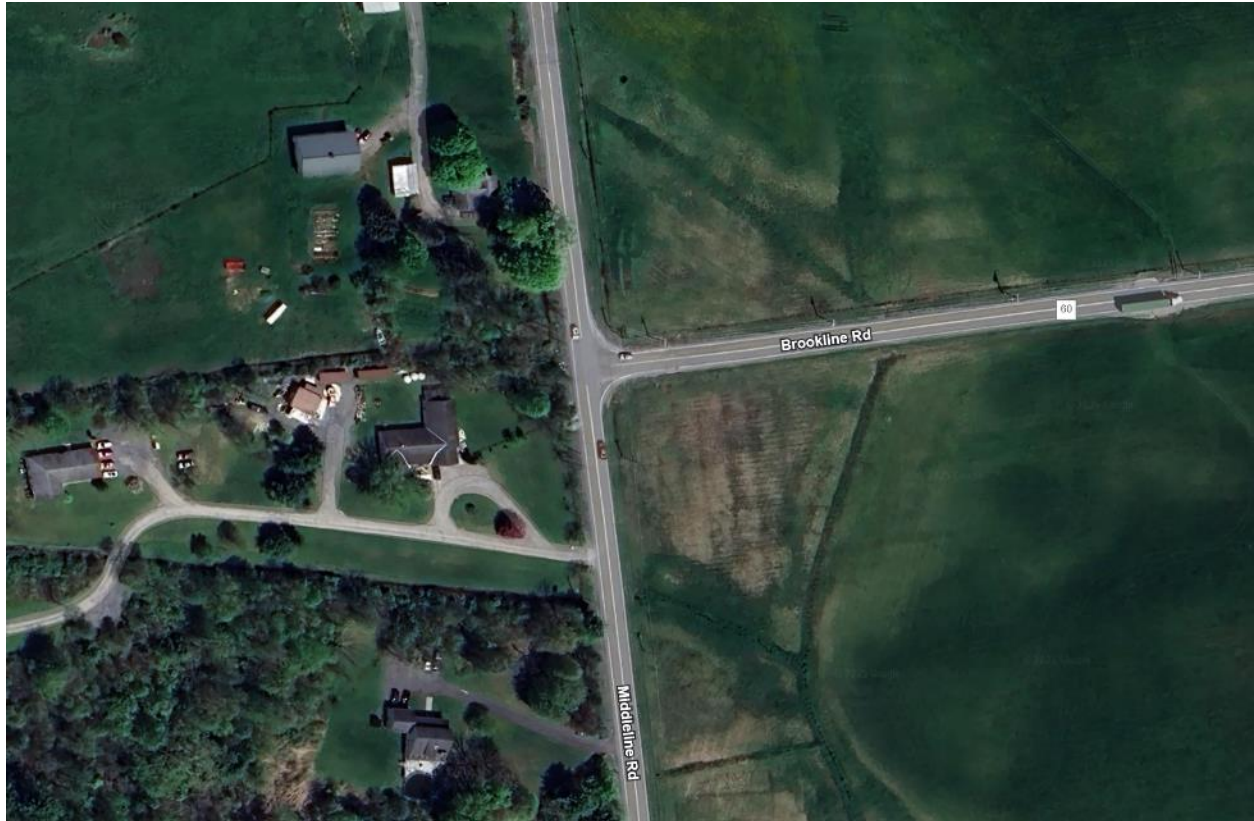
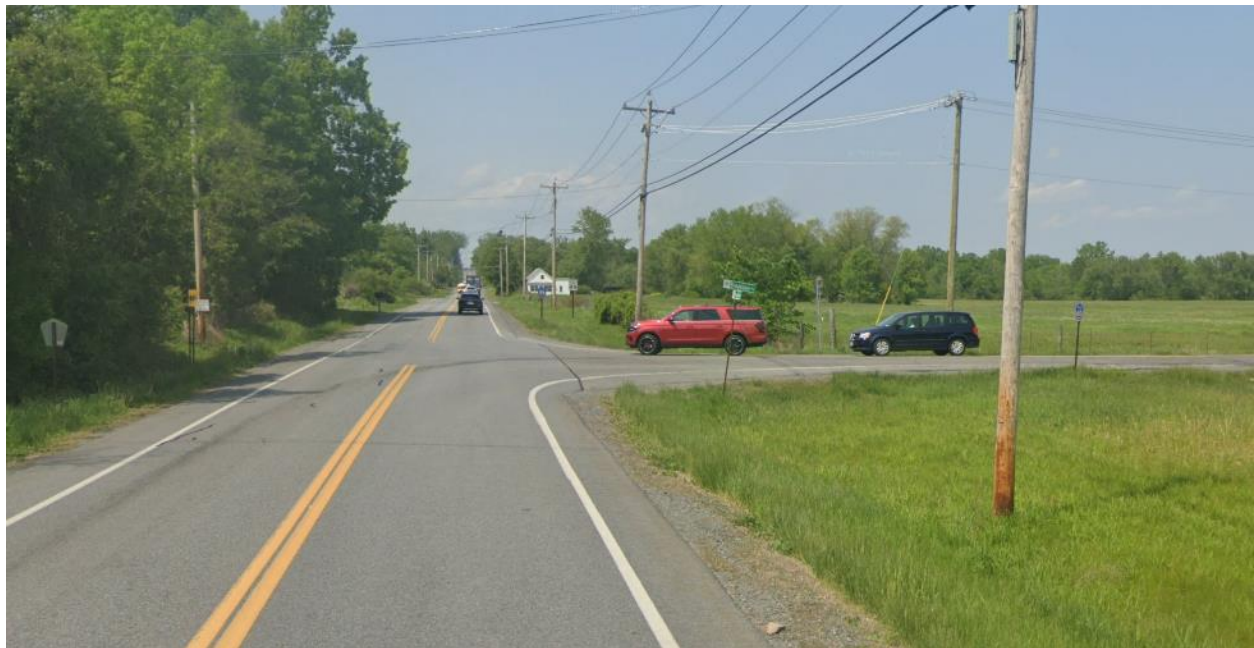
**Middleline Road and Brookline Road:**

- Three-legged right angle intersection. High speeds on the Middleline approaches makes turning off Brookline challenging. NYSDOT speed data collected during a traffic count reports average speed was 50.5 mph, and the 85th percentile speed was 51.1 mph. The posted speed limit is 45 mph. Trucks turning from Brookline need to wait for large gaps to safely begin turning.
- Short queues were observed on Brookline when vehicles wait to make a left turn.
- Left-turning trucks from Middleline onto Brookline were observed crossing the Brookline stop bar and centerline.

Recommendations at this location relate to improving intersection geometry to better accommodate truck turns, moderating vehicle speed on Middleline, and enhancing the visibility of the T-junction from the Brookline approach. Both roads are County roads, so coordination with Saratoga County on advancing these recommendations is required.

- **Paved shoulder widening:** vehicles were observed using the gravel shoulder to go around vehicles waiting to make left turns from Brookline. In addition, trucks were observed crossing far over the stop bar and centerline when making a left turn from Middleline southbound onto Brookline. Paving and widening the shoulders on the northeast and southeast corners could provide more space for trucks and vehicles pulling trailers to maneuver.

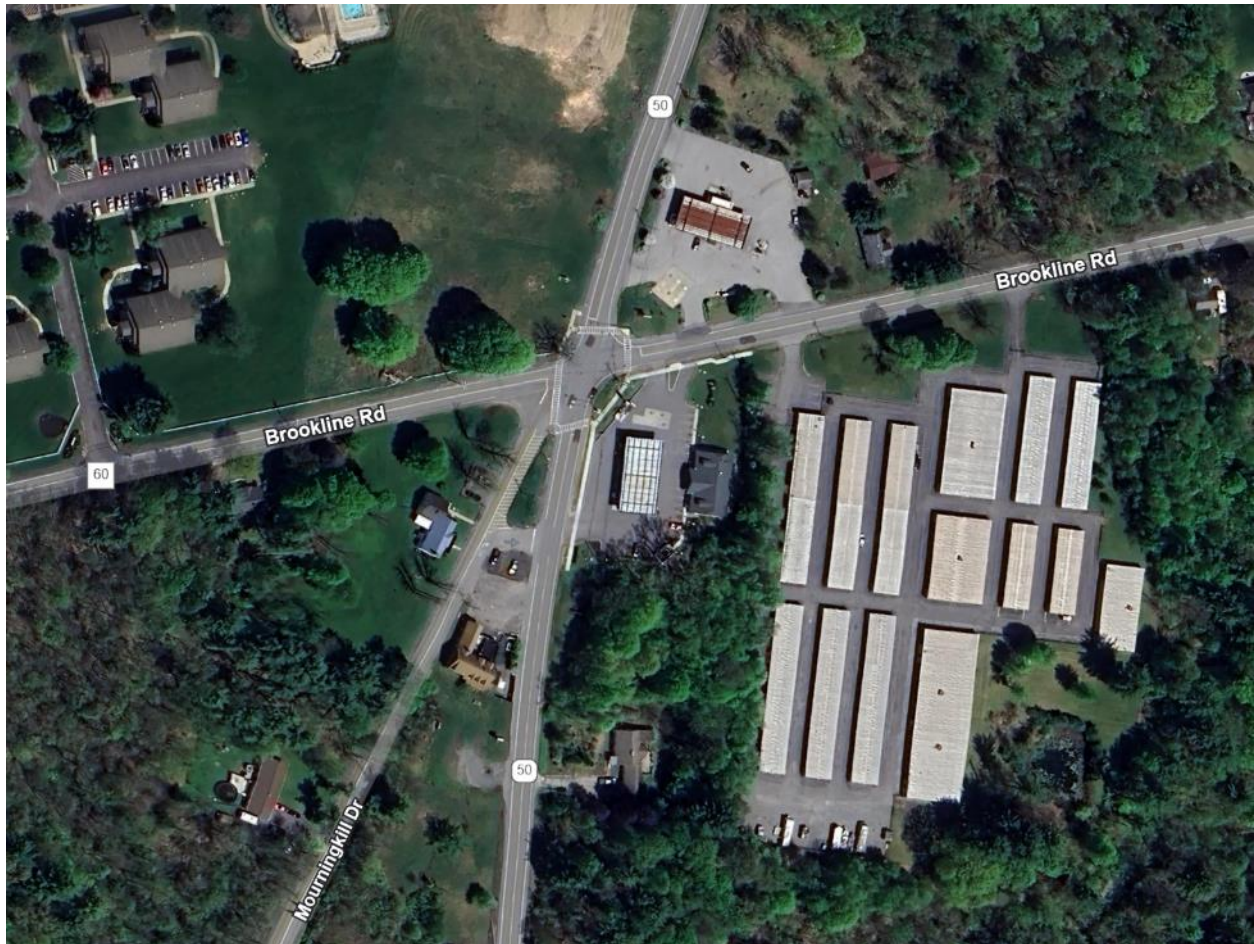
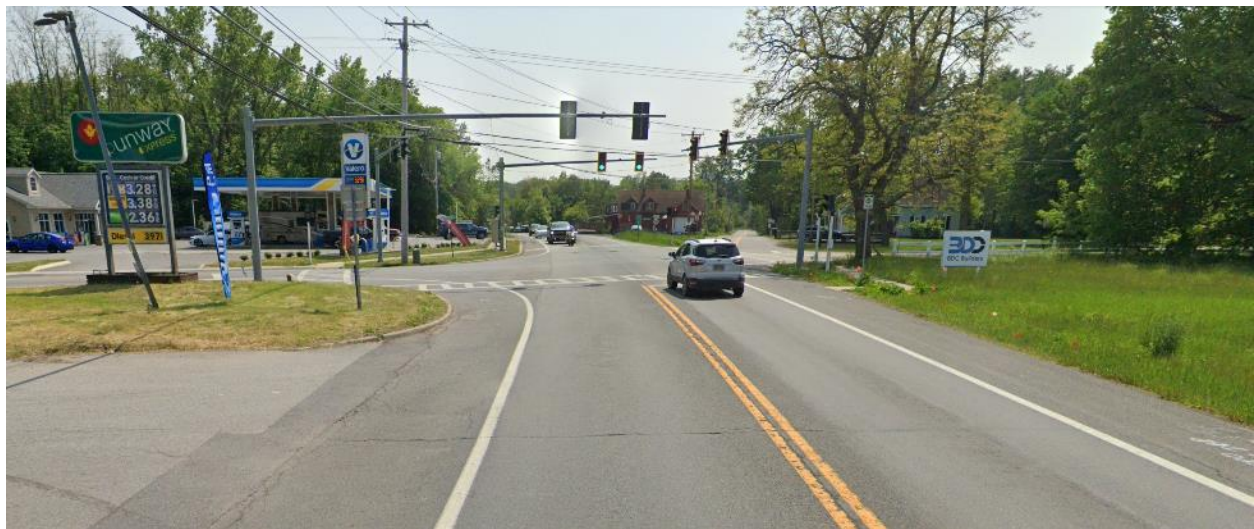
## Brookline and Route 50:

- Five-legged signalized intersection. The intersection is skewed, and Mourningkill exits the intersection to form a fifth leg.
- No turn lanes on approaches. Left-turning vehicles were observed to impede through-movements. On the southbound approach, through-moving vehicles would use the shoulder to pass. On the westbound approach, vehicles would wait in the middle of the intersection to make a left turn.

- Traffic congestion was observed during the weekday peak period of the field visit. Queues that did not clear within one cycle of the signal were observed on the northbound and southbound approaches at 3:30pm.

- Driveways are close to the intersection on the northeast and southeast corners. Queue conflicts were observed when vehicles enter or exit Valero through queues during red phases.

Recommendations at this site include evaluating dedicated left- and right-turn lanes, evaluating additional through lanes with lane drops on certain approaches, realigning Mourningkill to improve intersection geometry, access management improvements, and roundabout assessment. As State Route 50 is a State Highway, coordination with NYSDOT on advancing any of these recommendations is required.

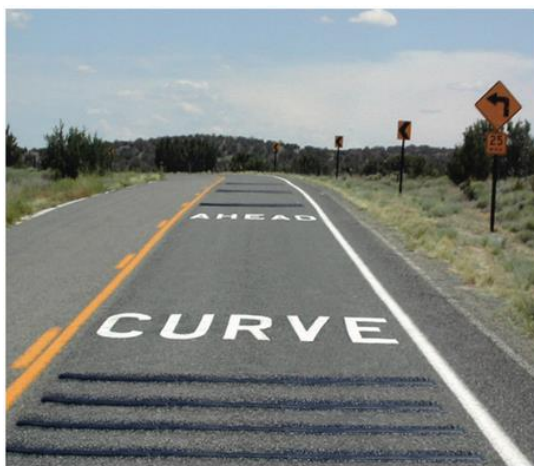
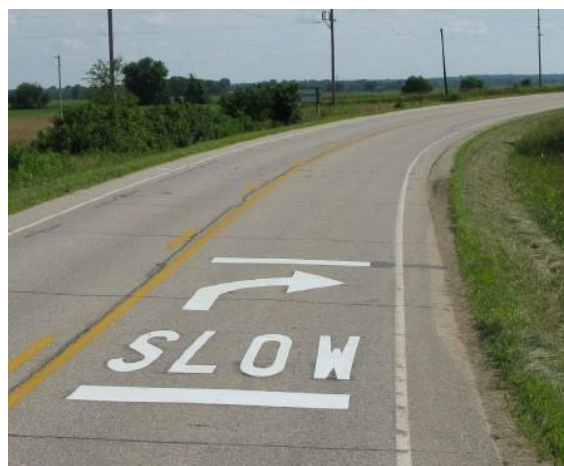
- **In-lane curve warning pavement markings:** these markings improve awareness of the curve. FHWA suggests that these markings may reduce crashes by 35%. Examples below.

Above, left: "CURVE AHEAD" paired with transverse rumble strips. Right: "SLOW" and arrow.

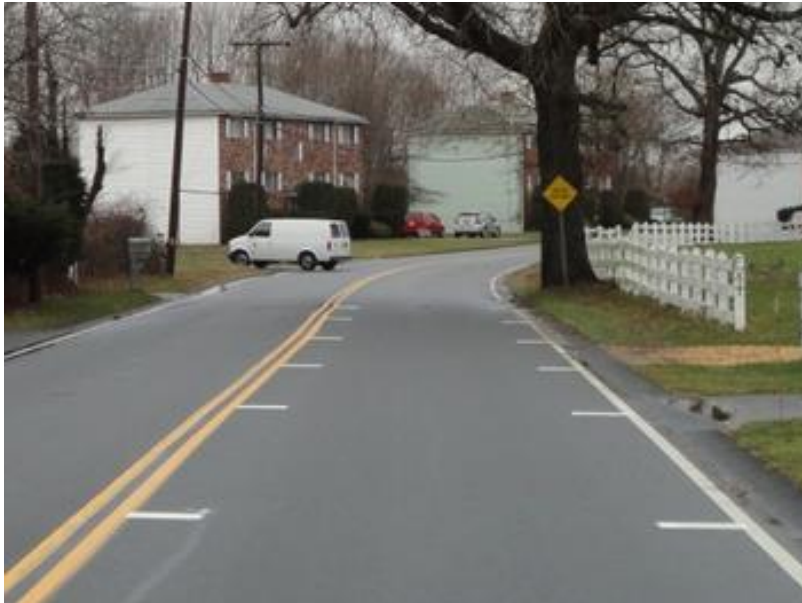
- **Optical speed bars:** transverse strips placed on the centerline and shoulders are spaced at gradually reducing distances. They are used to increase drivers' perception of speed and are a relatively low-cost countermeasure.

Above: optical speed bars on a curve approach

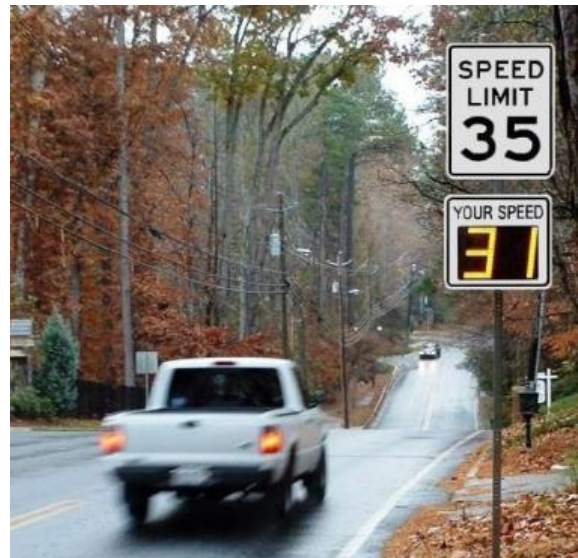
- **Dynamic speed feedback signs:** on Round Lake Road approaches, consider installing dynamic speed display/feedback signs. Per USDOT, 'research shows these types of signs have been effective at reducing speeds by 5 mph'. These signs may be installed permanently and can be solar powered for ease of installation.

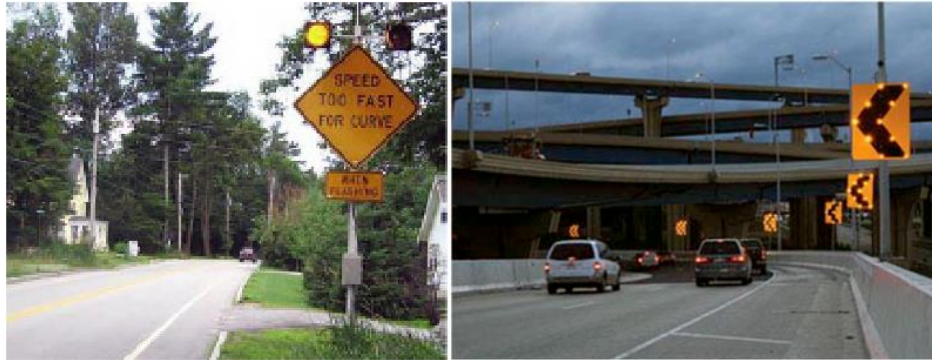
- **Dynamic curve warning signs:** instead of displaying vehicle speed, these signs light a flashing beacon when a vehicle is detected and is approaching too fast. FHWA states that studies have shown a speed reduction of up to 8.8 mph and a crash reduction of about 56%.

Above, left: "SPEED TOO FAST FOR CURVE" with radar-activated flashing beacons. Right: Sequential Dynamic Curve Warning System with LEDs within chevrons.

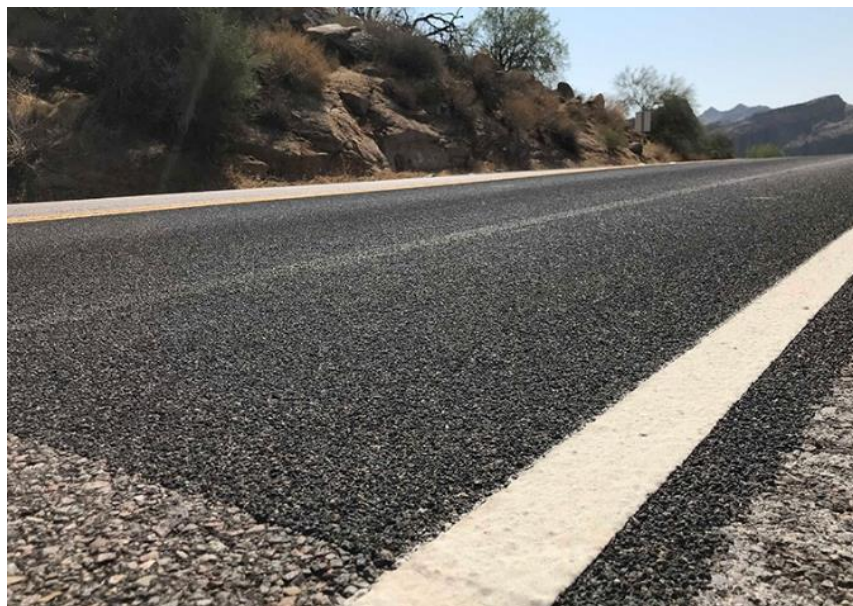
- **High Friction Surface Treatment (HFST):** as most crashes at the curve occur in wet conditions, improving pavement friction may help reduce crashes considerably. Per FHWA, HFST is estimated to reduce wet crashes by 83 percent and total crashes by 57 percent. HFST involves applying a layer of high-friction aggregate, such as crushed flint or bauxite, to the pavement using a polymer binder.

Above: HFST applied to a curve

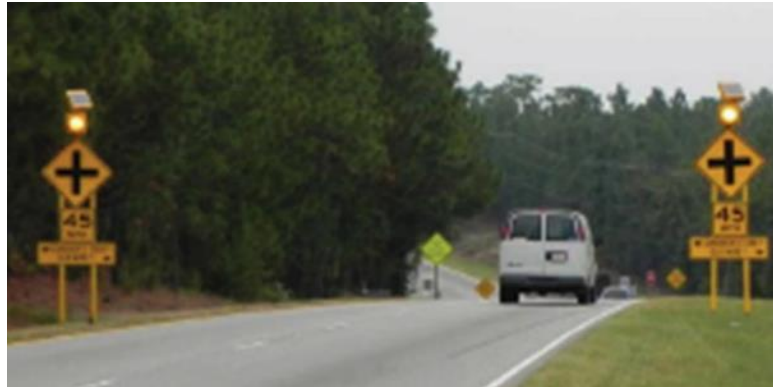
- **Intersection safety enhancements:** the USDOT publication “Systemic Application of Multiple Low-Cost Countermeasures at Stop-Controlled Intersections” lists recommendations for this type of intersection:
  - On the Middleline approaches, consider adding advanced intersection warning signs (MUTCD W2-2 signs). This can be coupled with supplemental street name plaques to improve driver awareness of the intersection.

Above: advanced intersection warning signs

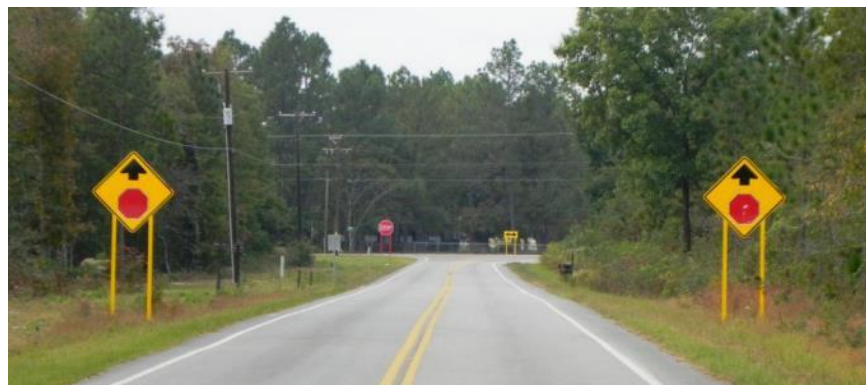
- On the Brookline approach, consider adding advance “Stop Ahead” signs (MUTCD W3-1 signs), oversized stop signs, doubled-up stop signs (on both sides), and retroreflective strips in sign posts. See example image below. The approach currently has an older “Stop Ahead” sign about 700 feet from the intersection that appears to have lost its reflectivity.

Above: advanced intersection warning signs
